# Manhole Inspection Summary

Manhole # S13CC1005MH

Insp Date: **6/20/07 8:55 AM**

**Location** Address: **3900 TOWANDA AVE**

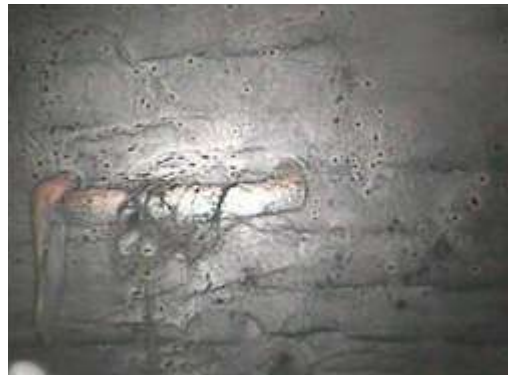
Defect 1

☒ **Evidence Of Surcharge**

Depth: **4** (ft.) ☐ Active Surcharge Present

EVIDENCE OF SURCHARGE

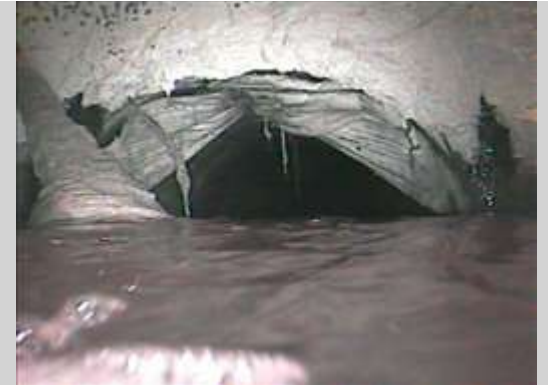
12 O'Clock Outflow

Pipe Height: **20.4** (in.) Rod and Bar (Angled)  
Pipe Material: **PVC** ☐ Pipe Lined  
Invert Depth: **17.57** (ft.) Flow Characteristics: **Fast**  
Deposits: ☐ None ☐ Mud ☐ Sludge ☒ **Debris** ☐ Grease  
Silt Depth: **4** (in.) Deposits Extent: **Light**  
Infiltration: **None** Pipe Seal Cond: **Sound**

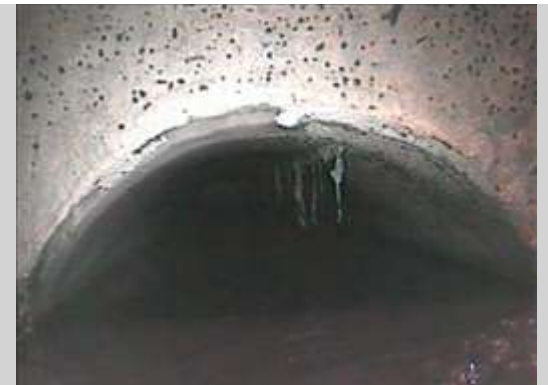
4 O'Clock Inflow

Pipe Height: **20.4** (in.) Rod and Bar (Angled)  
Pipe Material: **PVC** ☐ Pipe Lined  
Invert Depth: **17.17** (ft.) Flow Characteristics: **Fast**  
Deposits: ☒ **None** ☐ Mud ☐ Sludge ☐ Debris ☐ Grease  
Silt Depth: (in.) Deposits Extent:  
Infiltration: **None** Pipe Seal Cond: **Sound**

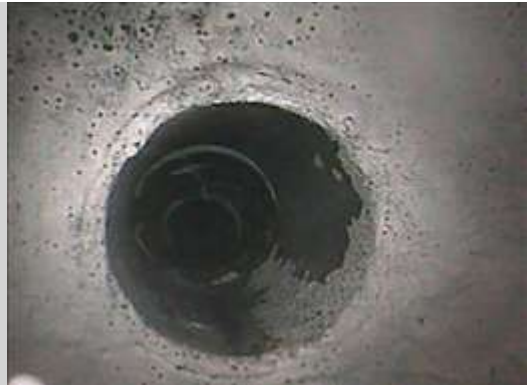
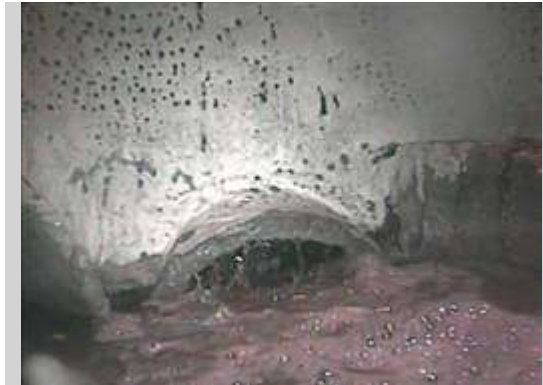
7 O'Clock Inflow

Deposits: ☒ None ☐ Mud ☐ Sludge ☐ **Debris** ☐ Grease

Drop: **Outside** Rod and Bar

Drop Condition: **Open**

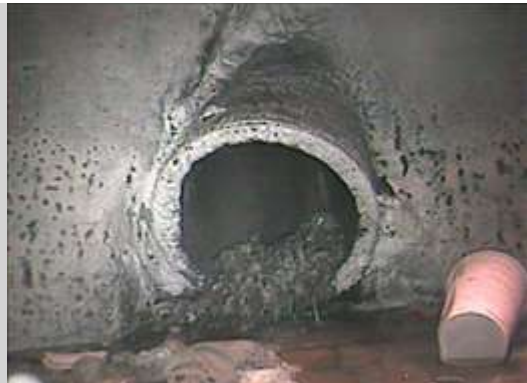
9 O'Clock Inflow

Deposits: ☐ None ☐ Mud ☐ Sludge ☒ **Debris** ☐ Grease

Silt Depth: **2** (in.) Deposits Extent: **Light**
